Aurizon Network 2015 Flood Infrastructure Claim Review

Cost Review of Aurizon Network's 2015 Flood Infrastructure Claim

RO037900/RPT/003 | C

2 August 2016

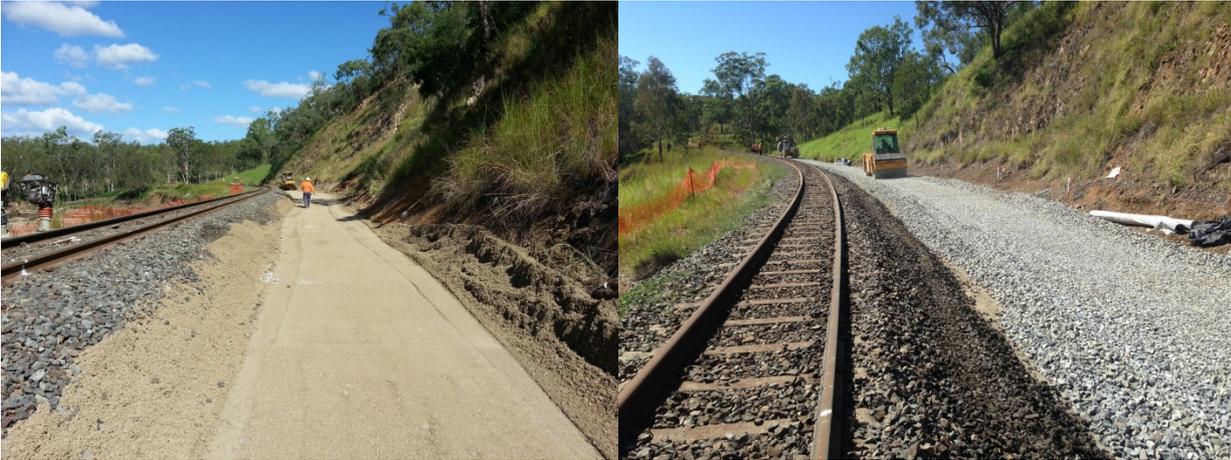
100.214 km to 100.527 km (313 m). Areas outside of these limits have not been considered for this claim. The width of the reinstatement includes temporary track alignment (track slued to the temporary position to allow trains to run during the embankment recovery works), re-instatement of the formation under the original track position and new access road (total width of 12 m). Where it has not been possible to measure accurately Aurizon Network standards and drawings (for example AUR-S-9999-2100) have been used. Ballast has been calculated on the amount required based on the evidence provided and has been calculated separately thus the cost projected is excluded from unit costs that already include the ballast cost. Our benchmark cost estimate for the Bells Creek track section flood repair works are explained below.

No formation works were completed for the temporary track alignment, ballast and top surface removal only, with ballast placed on top.

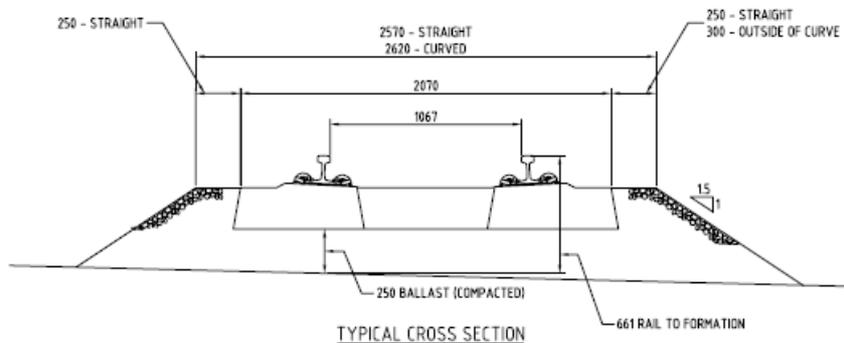
6.2.5 MSL 61 - Ballast estimate

Ballast expenditure of \$58,895 we have assumed covers only the cost to ballast the emergency works track alignment slued into the temporary position. The photography provided shows the temporary slue over 200 m of track. Using the drawings in Appendix F the track Slue limits were from 100.527 km to 100.214 km, 313 m in length. Using Aurizon Network Standards for typical cross sections of plain line track (see diagram below) we assumed a ballast width up to maximum 4,000 mm for 300 mm depth.

4,000 mm (standard ballast width including shoulders) x 274 m (314 m total slue – rounded down to 274 m to allow for nominal 20 m transition ramps) x \$60 unit rate = \$65,750. The total amount being claimed for ballast material at Bells Creek of \$58,895 is prudent cost and to standard and scope.

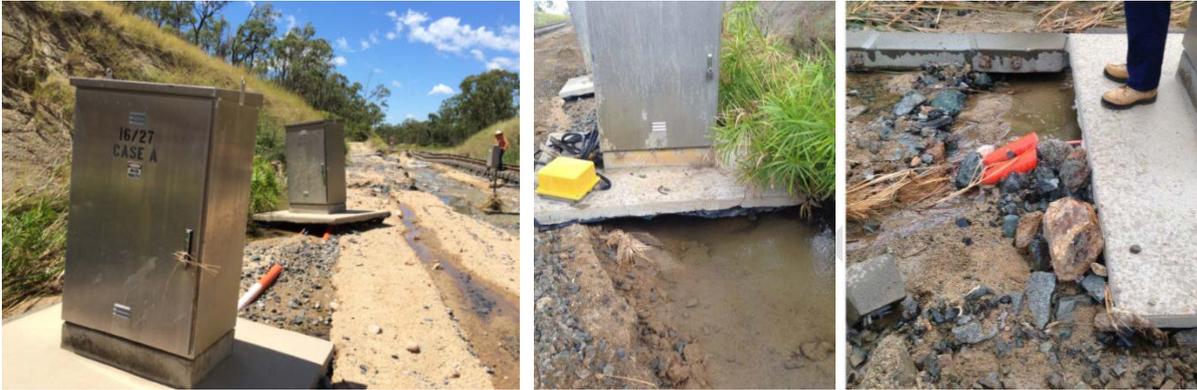
MSL1 – After the Flood, before re-instatement works

At Mount Rainbow there was a major damage to two signal boxes. Following inspection works and isolation of all electrical works Aurizon Network assessed that two LOC boxes were washed out of position and all works within to be tested and either repaired or reinstated as new. We have assumed all works for MSL1 are to be included as incremental maintenance costs. Aurizon Network's claim for this work activity is shown below in Table 5.3.

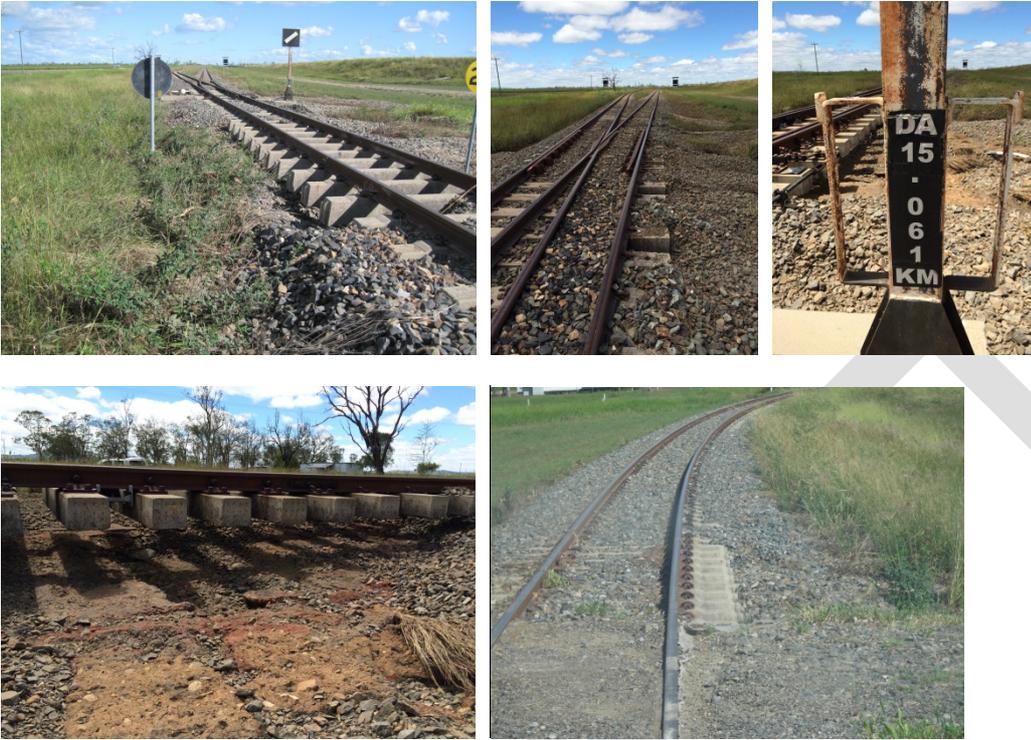
MSL69 – After the Flood, before re-instatement works

No. 12 Turnout point, ballast washout (Earlsfield end). Formation repair, turnout and panel removal required - rodding assistance required. As shown in the photographs in appendix D. The flood removed track ballast for a length of approximately 50 m. The claim below is for the opex works to re-instate the track to its former state. The incremental maintenance and asset maintenance costs claimed are as shown in Table 5.5.

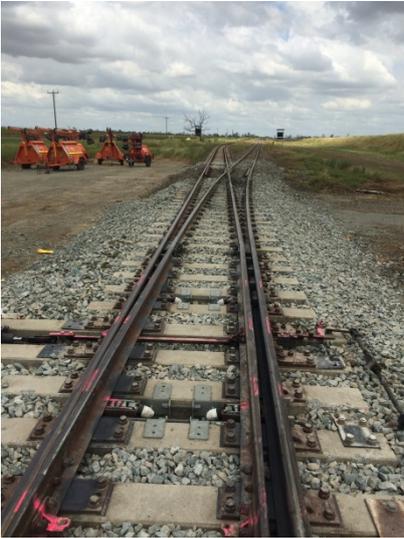
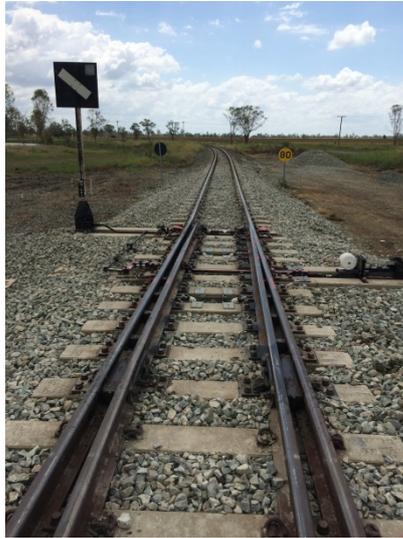
MSL69 – Completed works shown at turnout in both directions
