**Aurizon Network Pty Ltd (Aurizon Network) – FY2018 Capital Expenditure Submission**

2019  
Response to Draft Decision  
FY18 Capital Expenditure  
Claim

### IV.00154 - Autotransformer Renewal Project

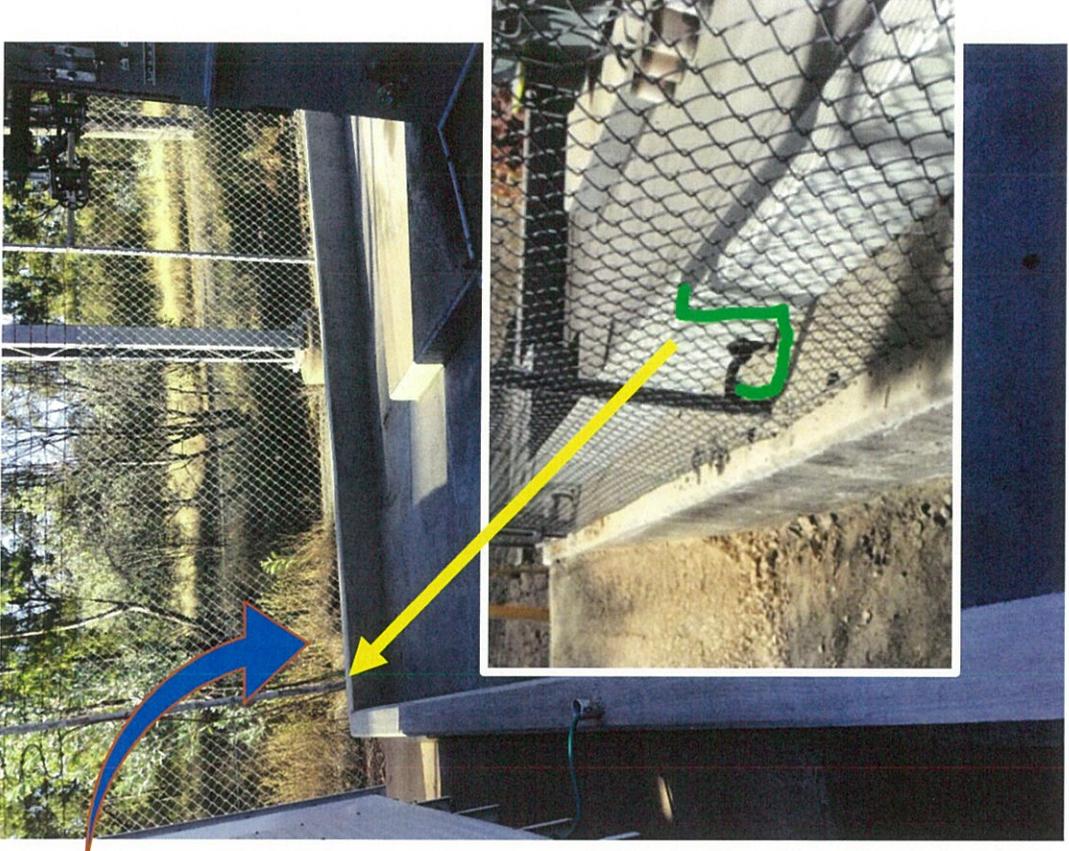
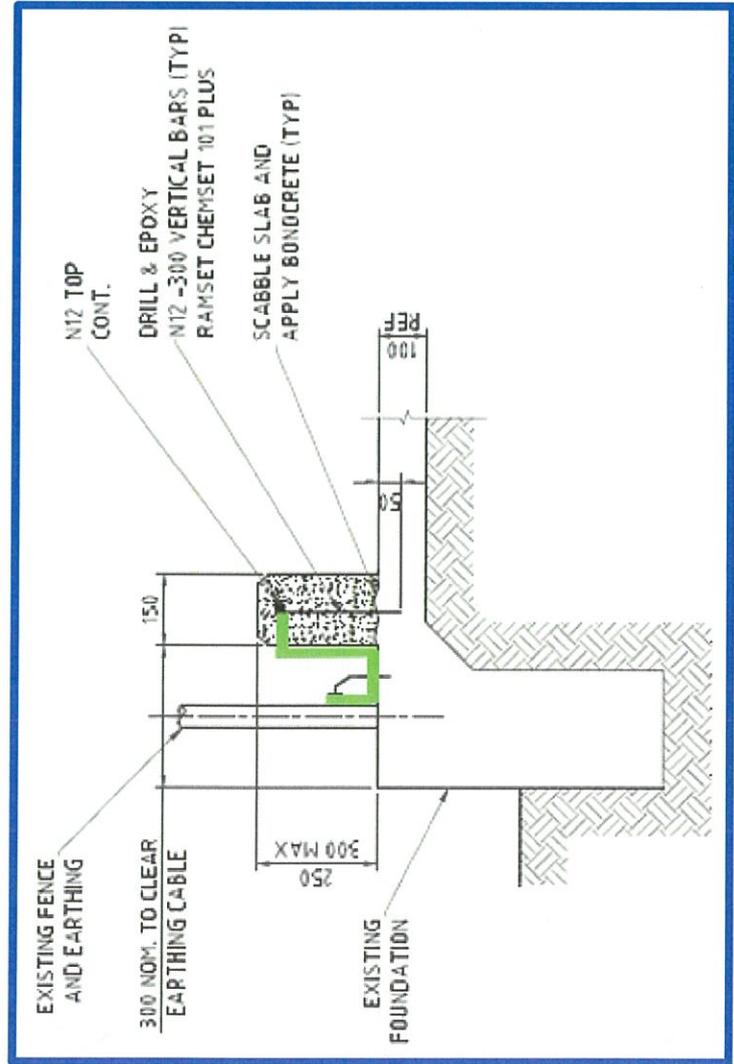
# Renewed AT Site – Proposed Bund Wall Reinforcement Earthing

Install a suitable Earth Conductor between Bund Wall reinforcing and site Earth Grid.

Cut/chase top of bund wall and expose horizontal N12 reinforcing bar. Clean bar and weld earthing bond to reinforcing bar. Lug earth conductor end and bolt to flat earthing strap. Flat earthing strap to be Hilti fitted for low, safe profile on outside face of bund wall and across existing slab. Bond earth strap to the existing earth grid at the enclosure fence.

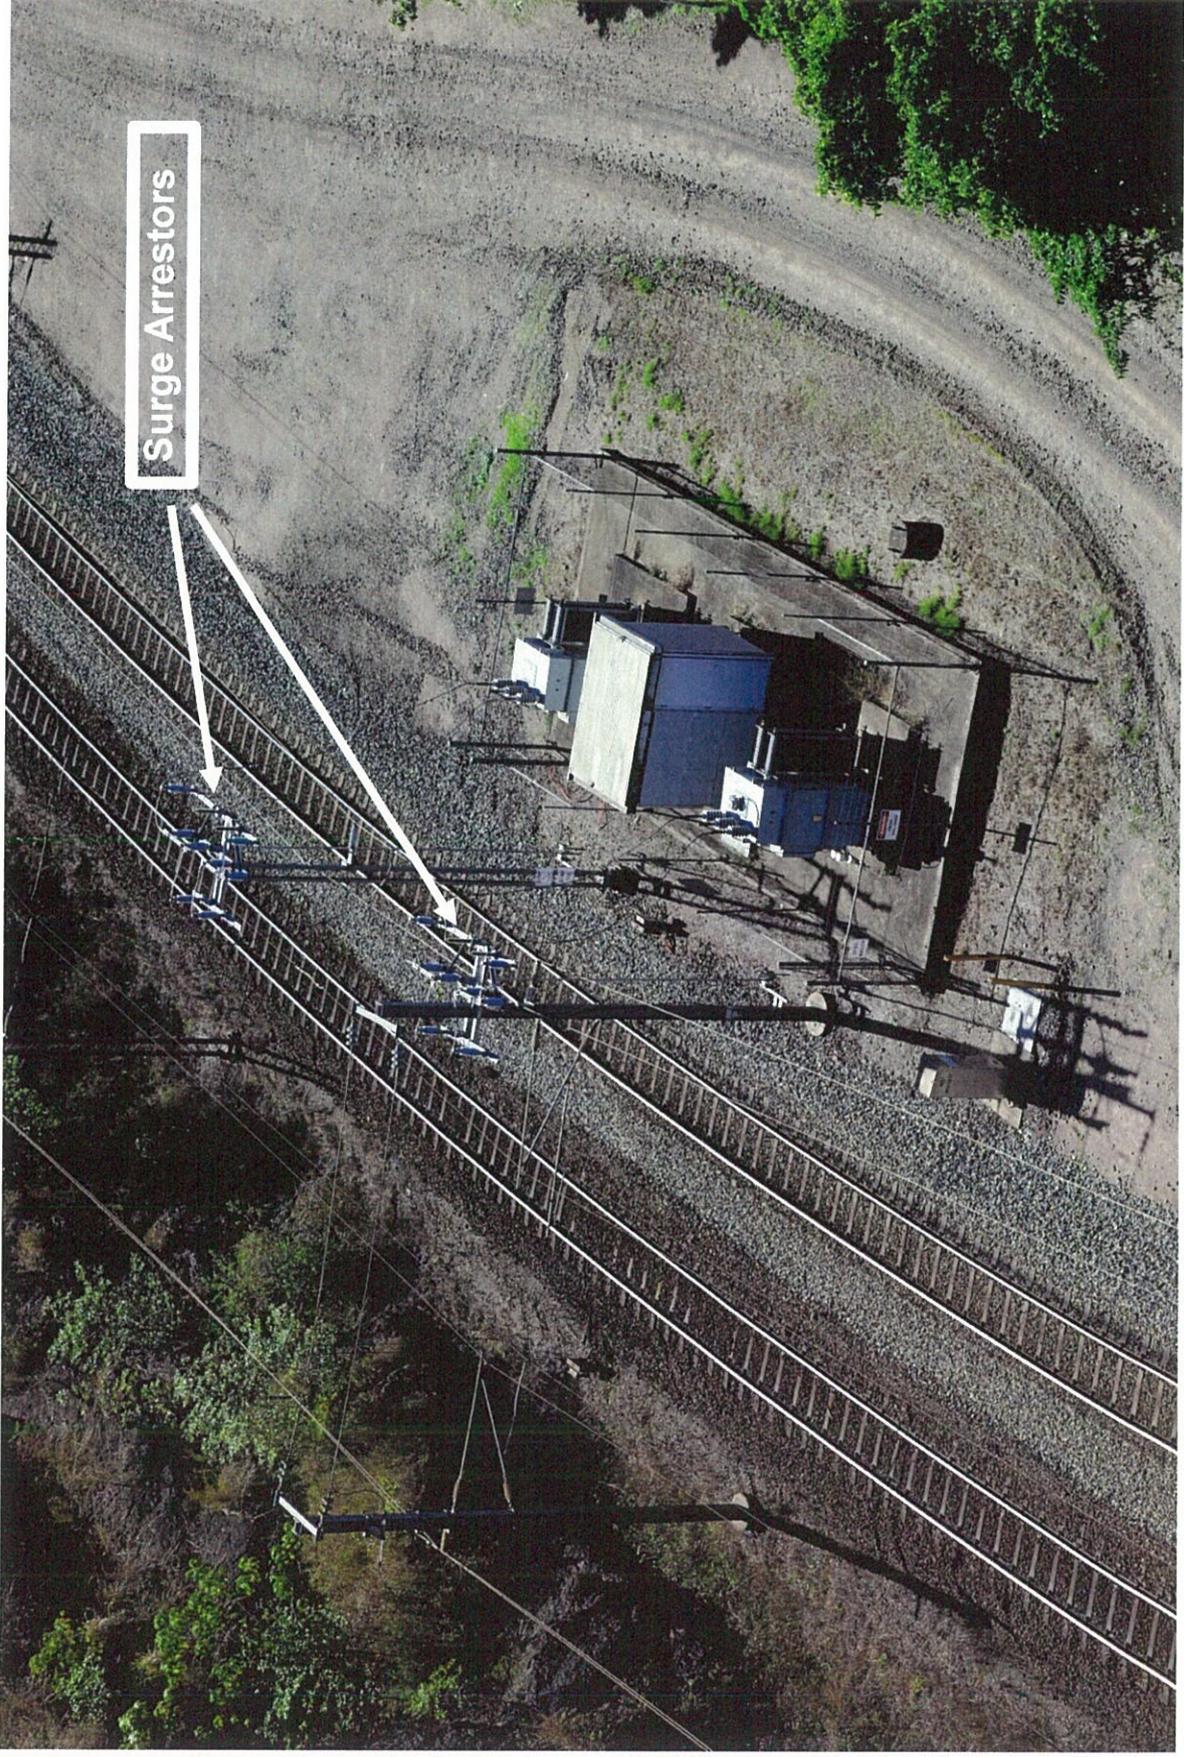
# Typical AT Site – Surge Arrestors Highlighted

# FIREWALL RISK ASSESSMENT EVIDENCE OF SURGE ARRESTOR INSTALLATION AT THE 3 AT SITES

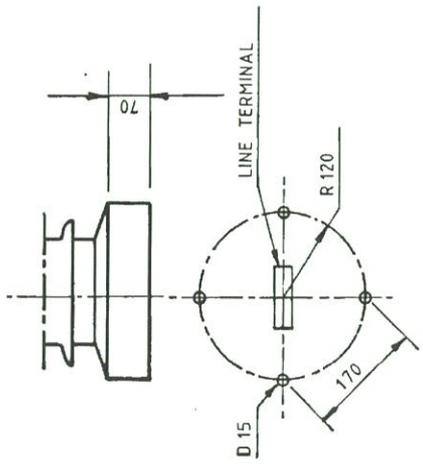
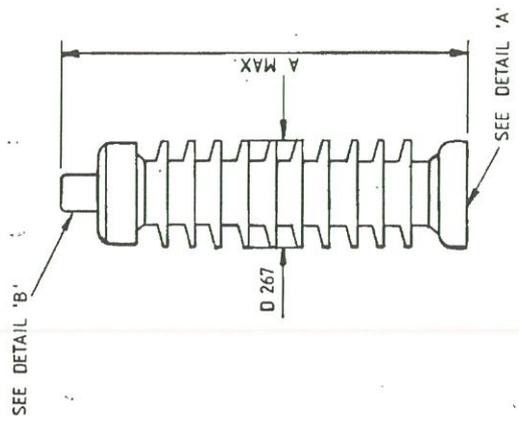
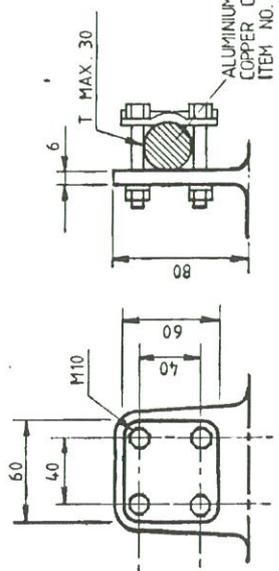
DETAIL 'A'  
DRILLING PLAN FOR ARRESTER  
WITHOUT INSULATING BASE

- NOTE.
1. SURGE ARRESTER SHALL BE SUPPLIED AS PER Q.R. SPEC DOE 154/061
  2. FIXING BOLTS, NUTS & WASHERS SHALL BE SUPPLIED WITH ARRESTER
  3. M12 x 120 lg. FIXING BOLTS C/W ONE NUT & ONE FLAT WASHER  
BOLTS NUTS & WASHERS TO BE HOT DIP - GALV.

LINE TERMINAL  
TYPE 'A' CAT. No. LB 910 314 - A

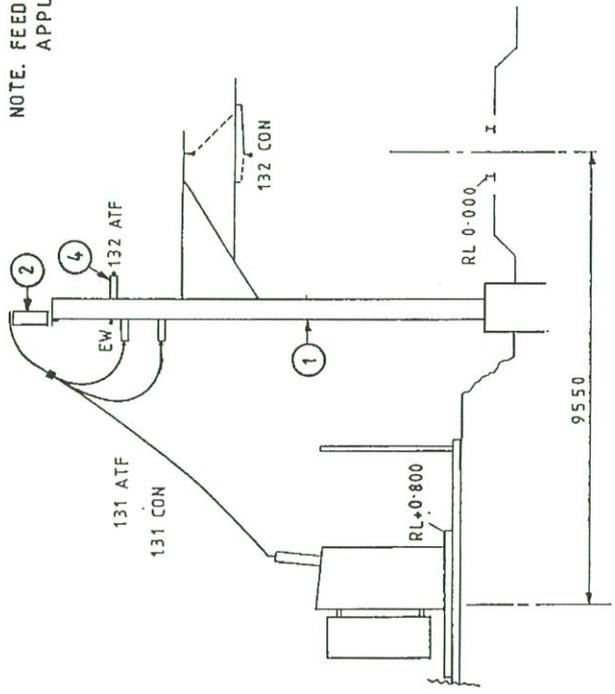
**WEST ELEVATION**

**NOTES**  
 1. A MINIMUM CLEARANCE OF 300mm SHALL BE MAINTAINED BETWEEN:-  
 (a) Active conductors, masts and/or associated steelwork.  
 (b) Active conductors and earth.  
 2. MINIMUM DISTANCE BETWEEN ALL 50/25KV FEEDERS SHALL BE 600mm.  
 3. THIS DATA SHEET IS TO BE USED IN CONJUNCTION WITH REFERENCE DRAWING — ATW/CW125 714

NOTE. FEEDER INSULATOR HEIGHTS AS APPLICABLE TO 29 PANEL MAST.

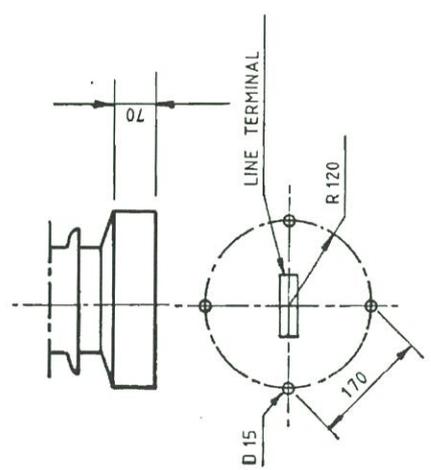
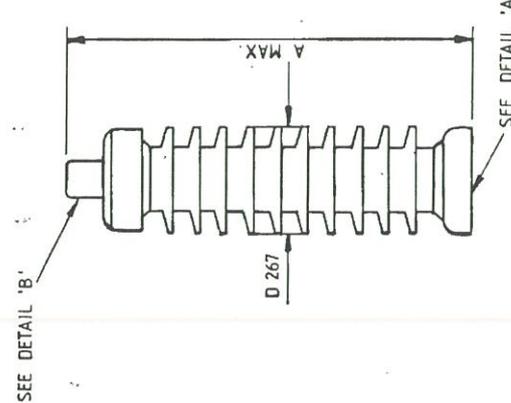
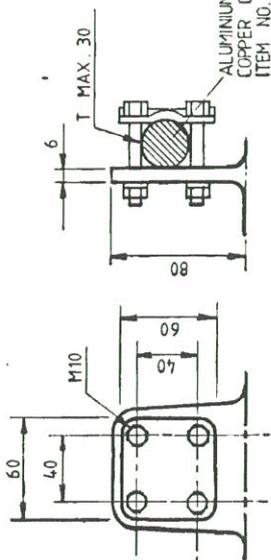
**DETAIL 'A'**  
**DRILLING PLAN FOR ARRESTER**  
**WITHOUT INSULATING BASE**

1. SURGE ARRESTER SHALL BE SUPPLIED AS PER Q.R. SPEC DOE 154/061
2. FIXING BOLTS, NUTS & WASHERS SHALL BE SUPPLIED WITH ARRESTER
3. M12 x 120 lg. FIXING BOLTS C/W ONE NUT & ONE FLAT WASHER
4. BOLTS NUTS & WASHERS TO BE HOT DIP - GALV.

ALUMINIUM CONDUCTOR WHEN USING  
 COPPER CONDUCTOR BI-METALLIC PLATE  
 ITEM NO. 451/004/001 IS TO BE USED

**LINE TERMINAL**  
**TYPE 'A' CAT. No. LB 910 314 - A**

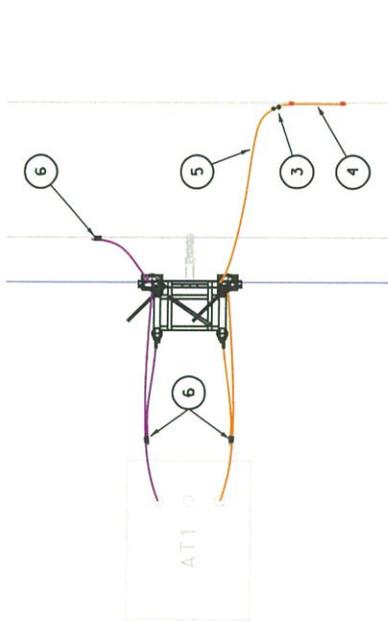
PLAN

ISOLATOR NUMBER LABEL  
 EP  AT1-I
